## Windemere Road Park, Alexandra Hills -

### CONDITION RATING - 3 – FAIR

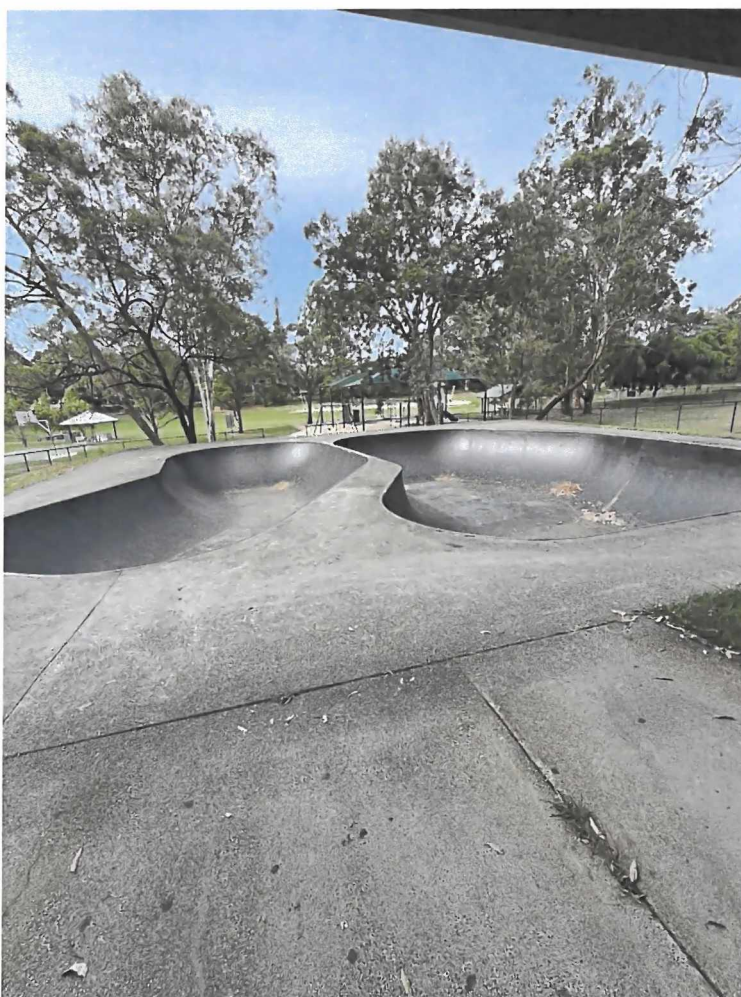
The two concrete transition bowls remain structurally sound, with a few significant cracks and minor surface hazards present. The concrete surface appears worn in some high-traffic areas but still provides an acceptable level of traction and rideability for intermediate to advanced users.

The primary bowl structures are currently serviceable, with no major structural failure observed at the time of inspection.

1. Any concrete chips / cracks wide joints (exceeding 5mm) and/or any irregularities in height (exceeding 3mm), including previous repairs, to be filled and/or ground smooth.
2. Repair coping around transition bowls

3. Any smaller concrete chips / cracks wide joints including previous repairs, to be filled and/or ground smooth. (CR3 due to size and location on the park)
4. As part of the rectification works, consider the adding street elements to the skatepark to improve function.
